SPECIAL AIRWORTHINESS INFORMATION BULLETIN

SAIB: CE-15-22

SUBJ: Wing Leading Edge Hinge-Pin Corrosion

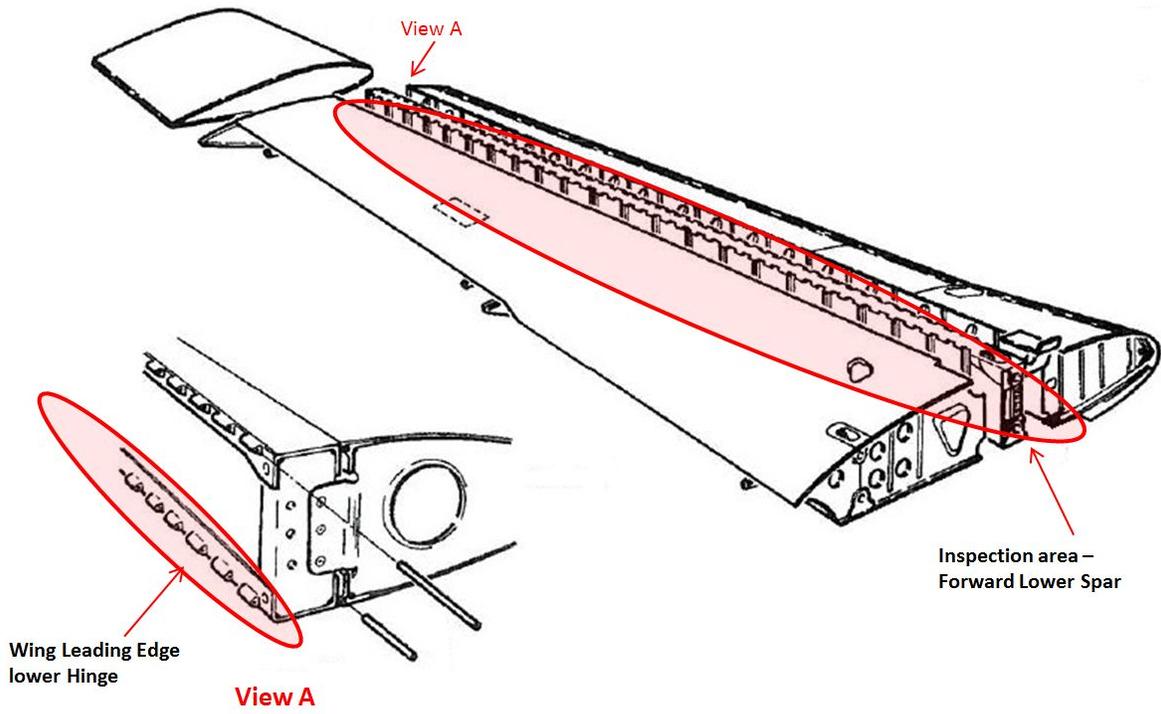
Figure 1: Inspection location

The FAA (Wichita Aircraft Certification Office (ACO)) investigated two reports of an extensive corrosion problem along the front spar leading edge lower hinge-pin attachment on two Beechcraft Model G36 airplanes.

The Beechcraft Model G36 design allows for the installation of either a corrosion resistant steel hinge pin or an alternative high carbon steel hinge pin. The two Beechcraft Model G36 airplanes, which were the subject of the original reports, both used the alternative high carbon steel material. Following the original report, 10 other aircraft have been discovered to have similar corrosion issues. Multiple Beechcraft Bonanzas and Barons have been affected.

We recommend that the front spar leading edge lower hinge-pin area be inspected for corrosion on all Debonair, Bonanza, and Baron Series airplanes with the described configuration. This inspection may be done during regularly scheduled yearly inspections.

During the annual inspection, we recommend you view the lower hinge and pin while the under wing access panels have been removed. If corrosion is found, you should contact Beechcraft Customer Support at 1-800-429-5372 or 316-676-3140 for further instruction. See figure 1 for inspection location.
